SERVICE BULLETIN

Log Number: 115

Models Affected: CMA-44, CMA-66

Subject: SCRAP TRAP SUPPORT BRACKET INSTALLATION

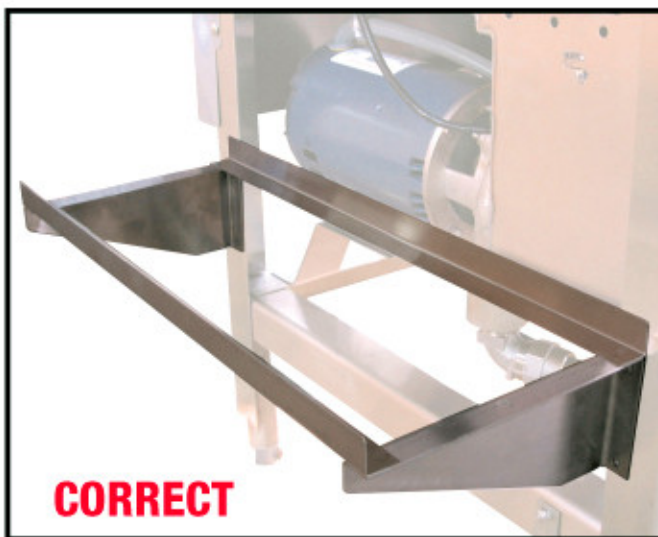
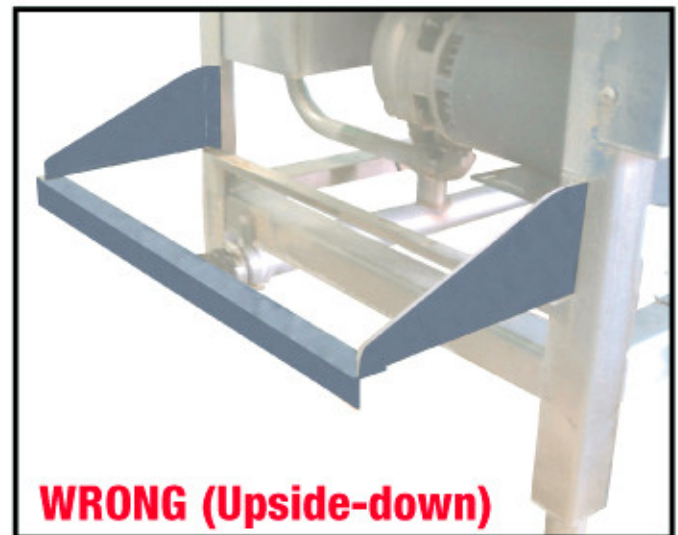
CMA has recently received calls regarding *splashing* that takes place in the area of the scrap trap on our conveyors. We have identified the *splashing*, which is related to the “Scrap Trap Support Bracket”, if mounted upside-down when installed in the field.

Make sure that the bracket is installed correctly, when attaching the “Scrap Trap Support Bracket” to the side of the machine. The illustration above shows the **CORRECT** and **WRONG** placement of this bracket. If installed upside-down, the scrap will sit lower on the frame, causing the water from the overflow to fall 5" to 6", and then deflect off the drawer onto the floor or side of pump motor. When the bracket is installed correctly the overflow is only 1" from the scrap trap drawer, and no deflection takes place.
