EQUIPMENT UPDATE

Log Number: EU-02-358

Part: 13504.12 Gear Reduce Left
13504.00 Gear Reduce Right

Models Affected: CMA-44 CMA-66

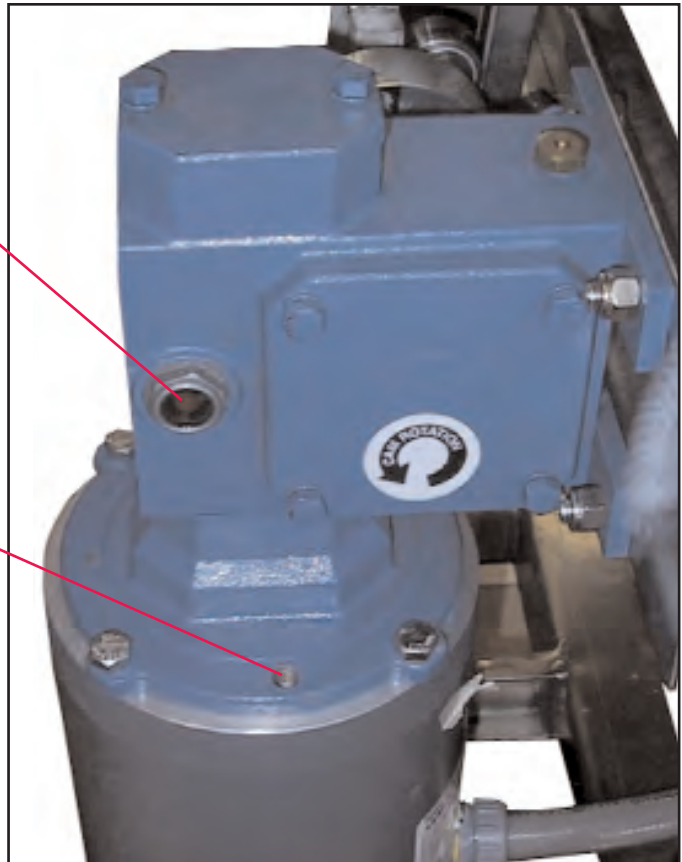
CMA now provides a Sight Glass on all gear boxes to monitor the oil level. If servicing the gear box and need to separate the motor from the gear box, remove 4 bolts connecting motor to gear box. Using the same bolts, thread bolts into separation flange holes simultaneously until motor separates from gear box.
