EQUIPMENT UPDATE

Log Number: EU-2-373

Part: DOOR HANDLE SUPPORT

Models Affected: MODELS AH, B, CMA180, CMA180T, CWS, EVA, CB, E

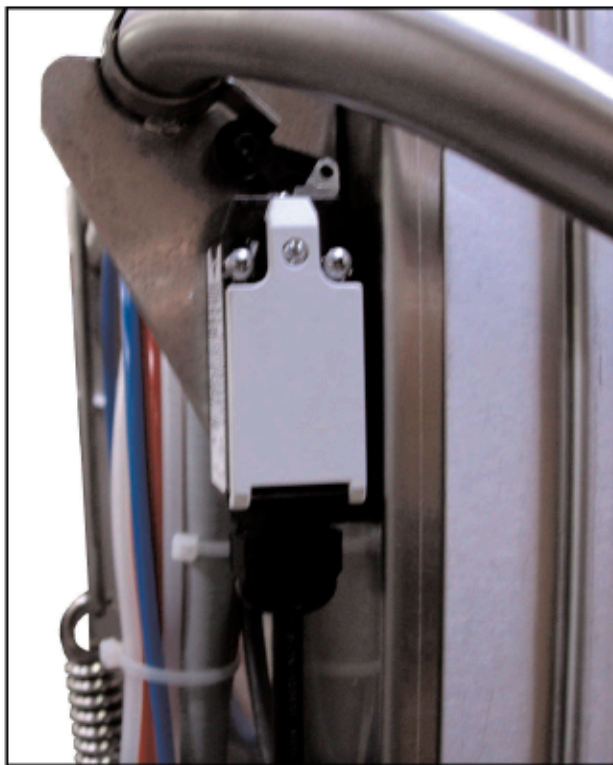
PHOTO A

Field reports indicate the door safety switch (photo A) has the potential of coming loose and causing machine malfunctions. A CMA service representative has suggested the following change be made - Install screw with nut behind the door safety switch. (See the screw with nut placed along side of door safety switch - photo B). The change has been made by pivoting the lower end of the switch towards the back of the machine, drilling a hole for a screw and nut and securing in place. The head of the screw prevents the switch from coming out of alignment or moving. Future machines will have this change. Suggestions from CMA Service Representatives are always welcomed and appreciated.
