EQUIPMENT UPDATE

Date: 3/8/04
Log Number: EU-03-362

Part: ALL CMA-44/66

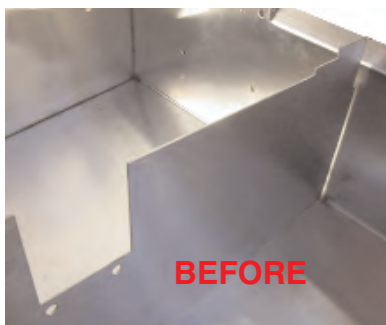
44/66 TANK DIVIDER

CMA has modified the tank divider to incorporate a 45 degree bend 2 inches from the top of the wall. The angled surface prevents water carry-over from the wash tank into the pre-wash tank. Models already in the field can simulate this change by installing P/N 13902.40, Tank Recovery Brackets.
